HVAC READINESS

A CASE STUDY IN DENVER PUBLIC SCHOOLS // 2020

published June 2021

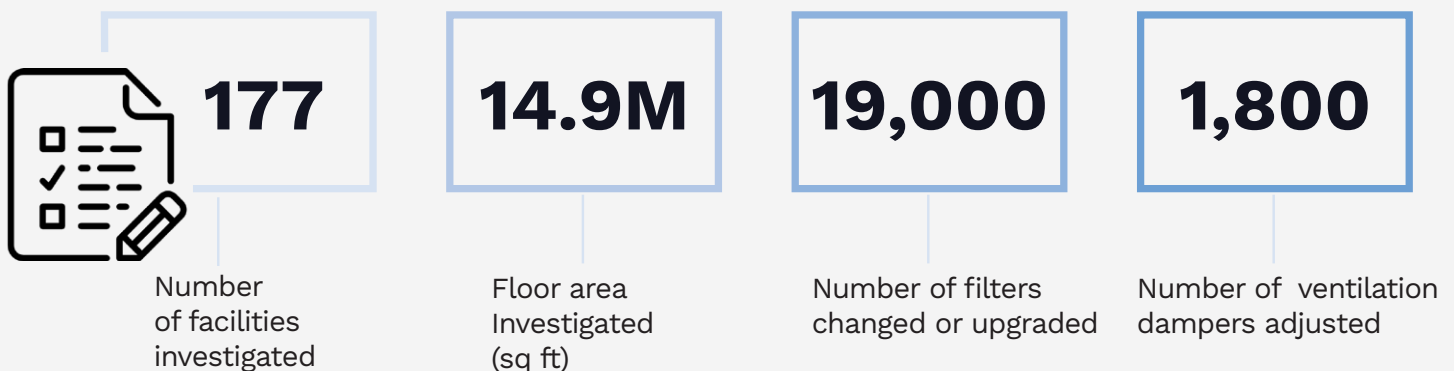
4 major **types of HVAC systems** assessed in **177** buildings & the **percentage of schools equipped** with each type:

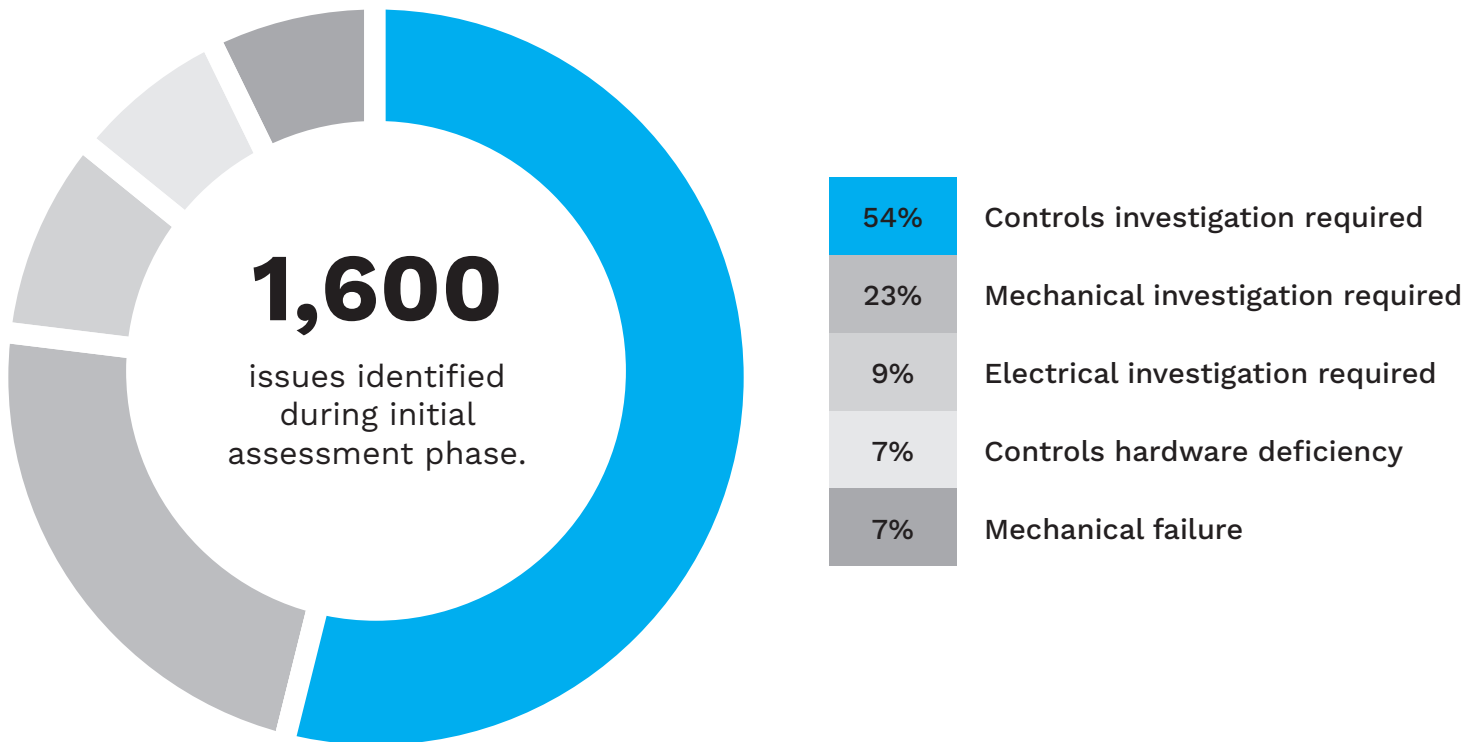
Root-cause breakdown.

Based on the BAS Analysis, McKinstry identified **over 1,600 issues** remotely. The majority of the analysis was performed within a 70-day window.

The issues were categorized according to the following potential root causes:

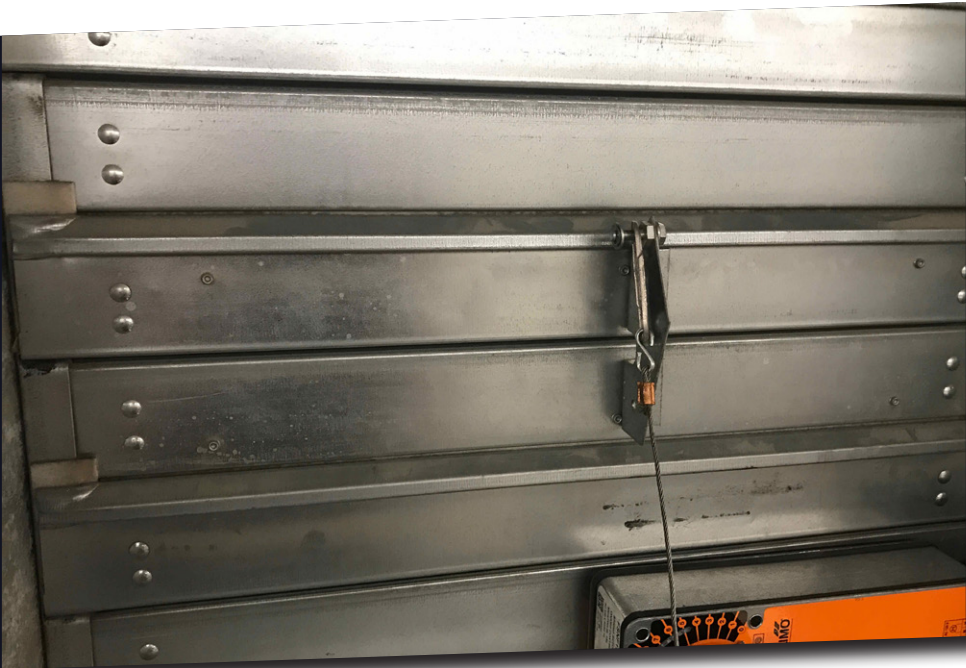
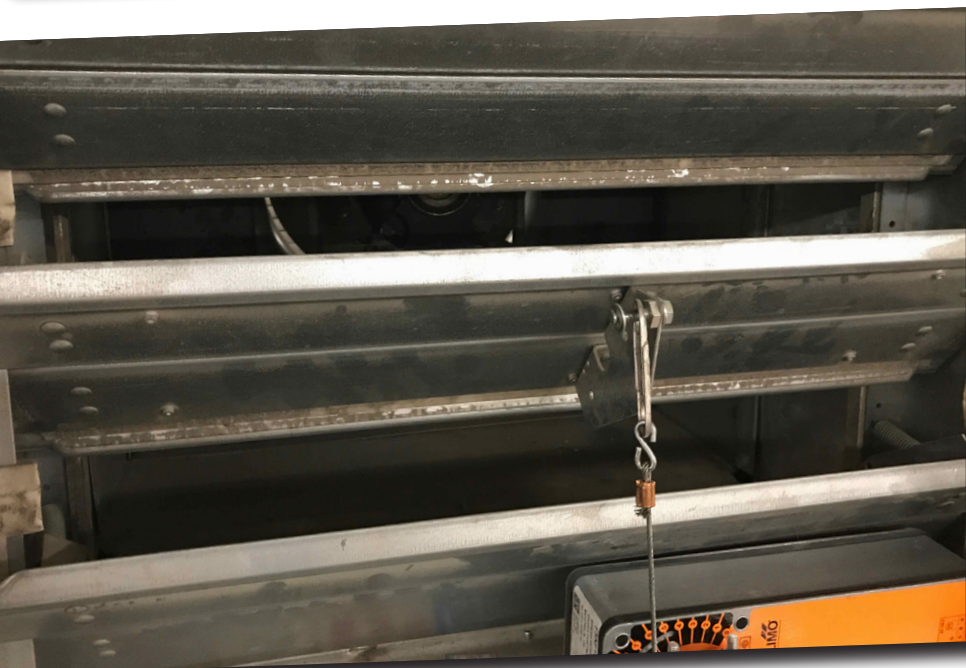
Controls. Outside air damper adjustment.

A completely closed damper (top) adjusted to the minimum outside air damper position (bottom).

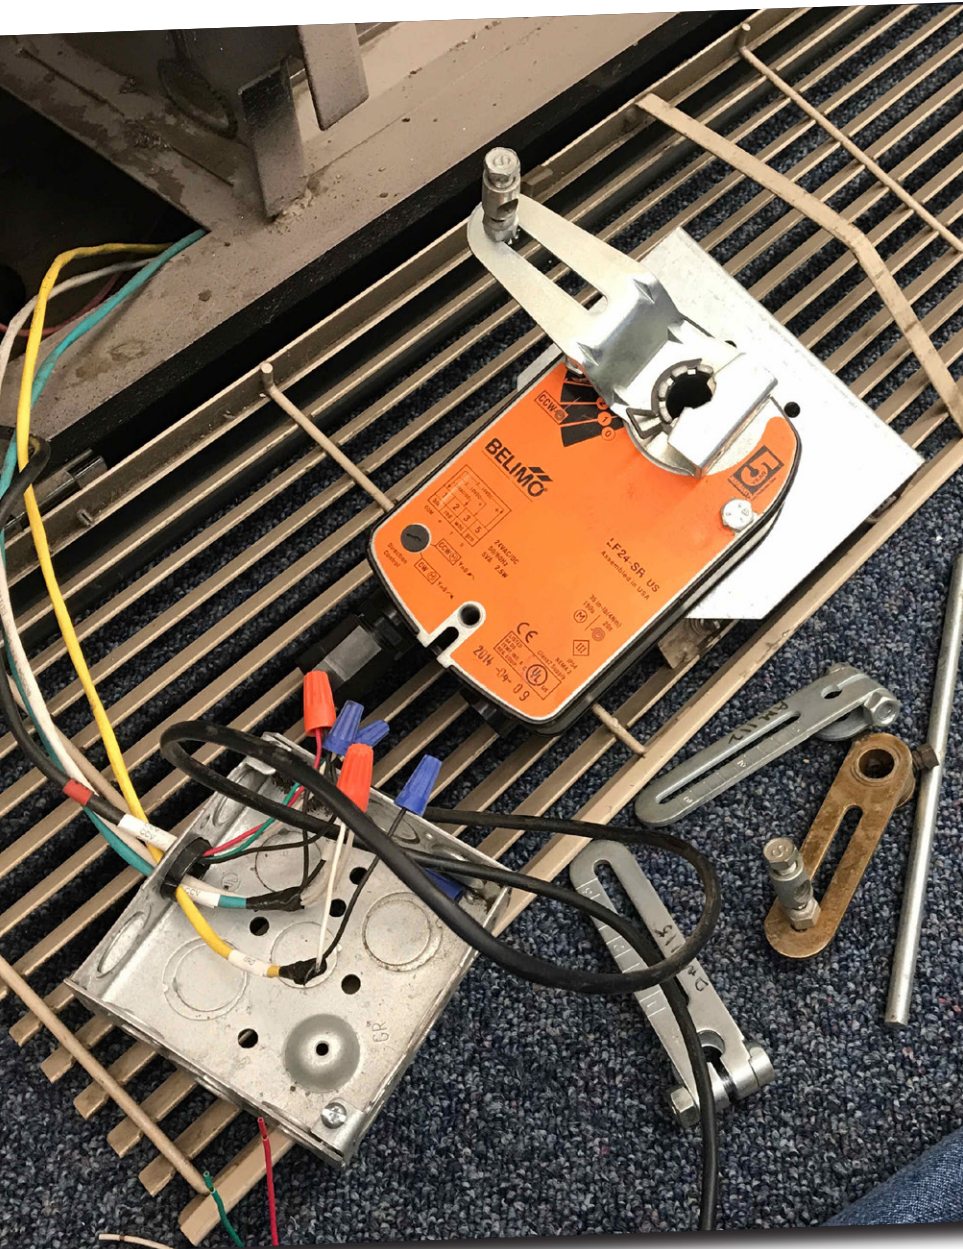
Controls. Uninvent outside air damper repair (left).

- Tighten Damper/ Louver Blades
- Repair/Replace On/ Off HOA Switch
- Economizer Controller Replacement
- Actuator Settings
- Freezestats Tripped
- Sensor Replacement/ Recalibration
- VFD Reset
- Pneumatic controls air supply leak.

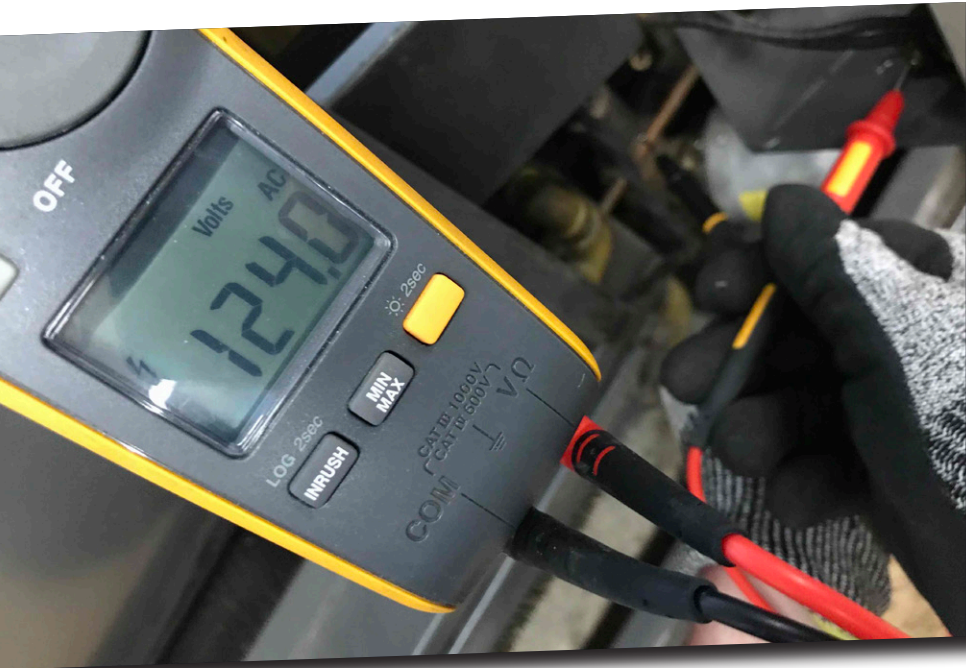
Electrical. Uninvent temperature controller test (top).

This test addressed wiring issues, blown fuses, and other electrical malfunctions.

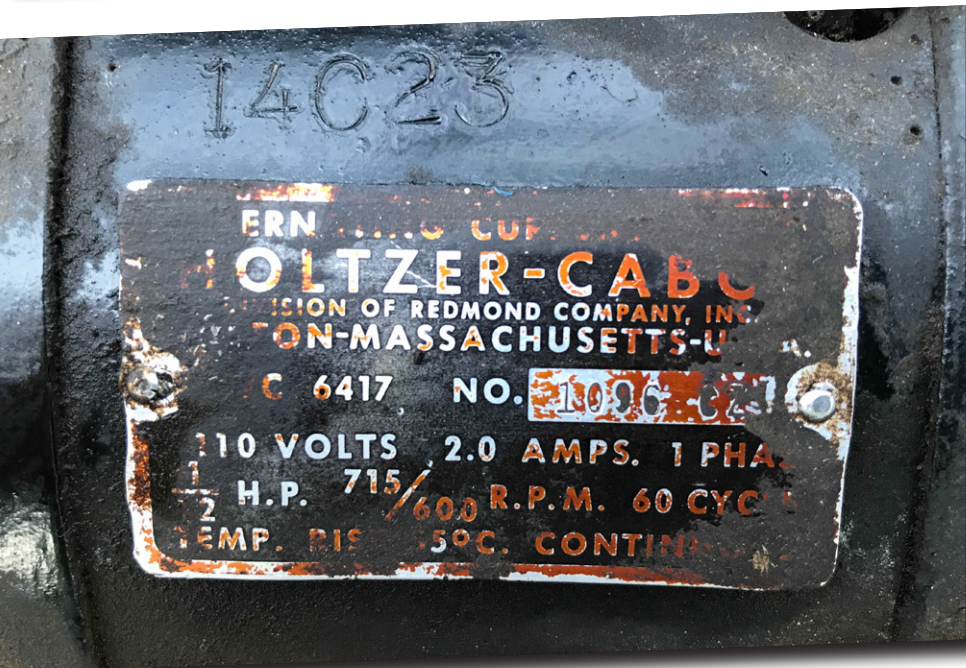
Equipment. Old equipment component (bottom) replacement, including

- Motors
- Shaft bearings
- Belts
- Motor starters
- Capacitors
- Compressors.
